EARTHQUAKE PERFORMANCE ASSESSMENT OF RENTAL LOW- COST HOUSING FLATS IN LOMBOK, INDONESIA

EARTHQUAKE PERFORMANCE ASSESSMENT OF RENTAL LOW-COST HOUSING FLATS IN LOMBOK, INDONESIA

D. Dinariana⁽¹⁾, Suwito⁽²⁾, H. N. Nurjaman⁽³⁾, B. Hariandja⁽⁴⁾, B. Staniarto⁽⁵⁾, G. W. Saputro⁽⁶⁾, A. D. Kusuma⁽⁷⁾

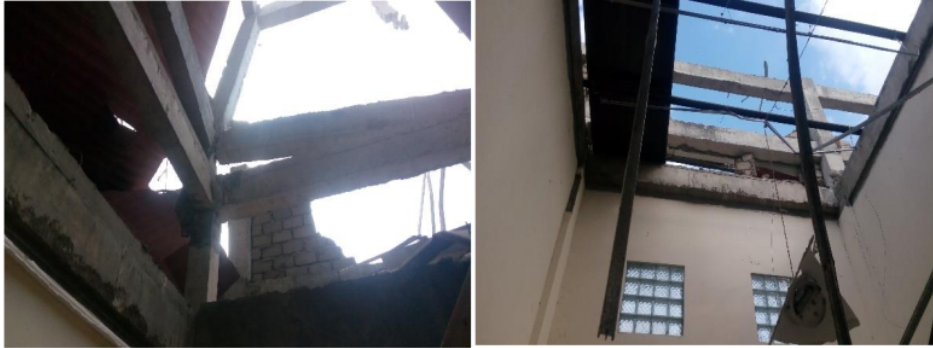
- Housing flat PP. Al Ikhlas, moderate damage level, conventional reinforced concrete structural system
- Housing flat Dalmas Polres Lombok Barat, North Lombok Province of NTB, major damage level, conventional reinforced concrete structural system

Fig. 3 – Example of major damage to structure caused by the earthquake: Crushing at beam-column joints at the North Lombok Police Station housing flat

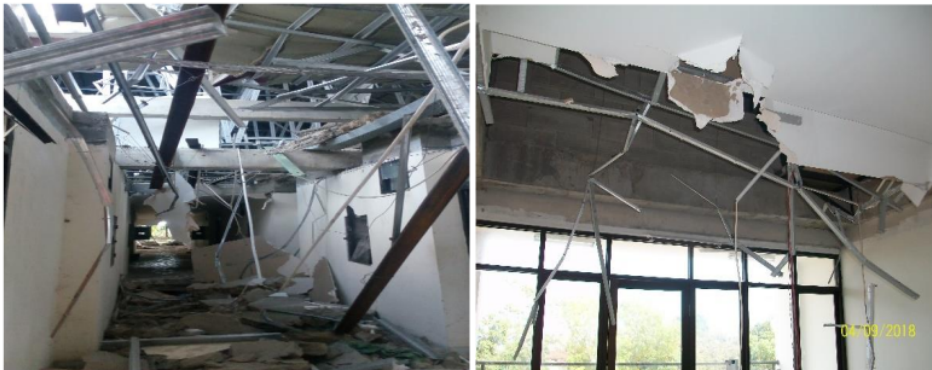
Fig. 4 – Example of architectural damage caused by the earthquake: Ceiling damage due to the falling of the material above it at the rental low-cost housing flats

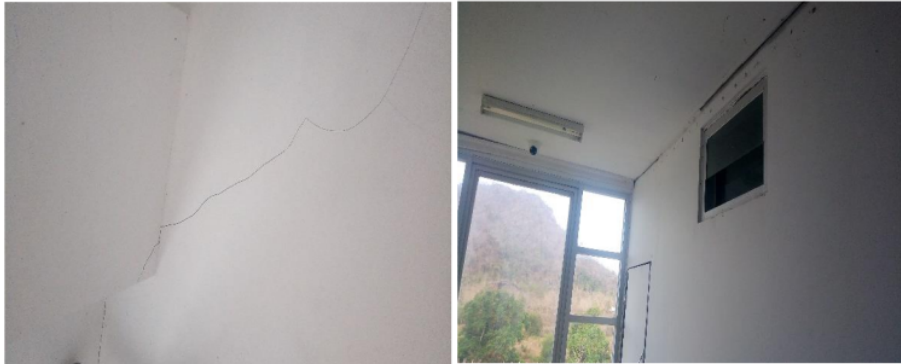
Fig. 5 – Example of minor damage caused by the earthquake: Hairline Cracks on the wall and falling of ceiling list at Sumbawa Technology University flats

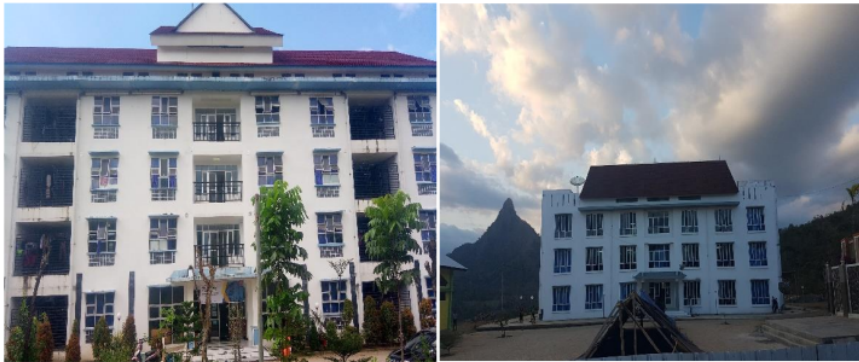
Fig. 6 – No earthquake damage to housing flats of (a) UTS and (b) Dea Malela Sumbawa

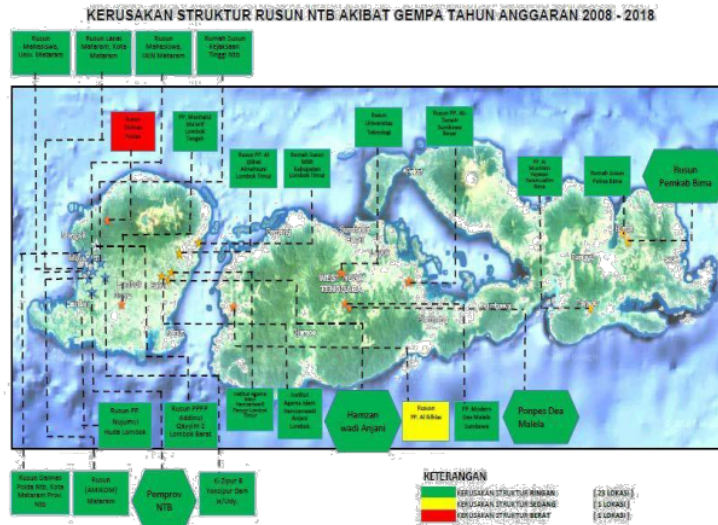
Fig. 7 shows distribution of 25 housing flats undergone structural damage. In general, the housing flats only have minor damage (92 %). These findings show that the structural performance of housing flats built by Ministry of Public Work and Housing in Lombok, Sumbawa, Bima and Mataram are quite good considering that many buildings in the surrounding area showed worse structural performance. In other word, these housing flats have proven to be earthquake resistance as designed. It should be noted that housing flats built using precast structural system show better structural performance compared to those built using conventional reinforced concrete structural system. Only housing flats built using conventional reinforced concrete system undergone moderate and major structural damage.

Fig. 7 – Map of structural damage on housing flats in Lombok, Sumbawa, Bima and Mataram due to earthquake

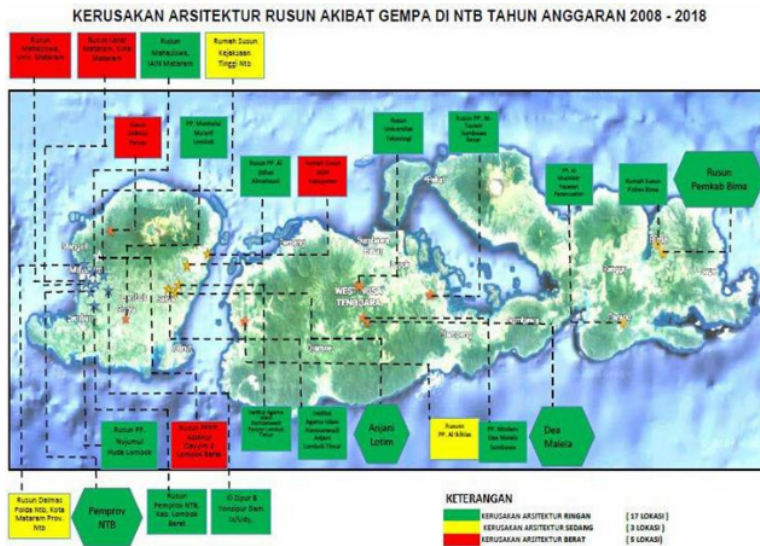
Fig. 8 shows distribution of 25 housing flats suffered architectural damage. As can be seen there are several housing flats underwent moderate (3 buildings) and major (5 buildings) damage. Meanwhile the other 17 buildings only suffered minor damages.

Fig. 8 – Map of architectural damage on housing flats in Lombok, Sumbawa, Bima and Mataram due to earthquake
