# DAMAGE ASSESSMENT OF RENTAL LOW-COST HOUSING FLATS IN CENTRAL SULAWESI INDONESIA AFFECTED BY PALU EARTHQUAKE

## DAMAGE ASSESSMENT OF RENTAL LOW-COST HOUSING FLATS IN CENTRAL SULAWESI INDONESIA AFFECTED BY PALU EARTHQUAKE

Suwito<sup>(1)</sup>, D. Dinariana<sup>(2)</sup>, H. N. Nurjaman<sup>(3)</sup>, B. Hariandja<sup>(4)</sup>, B. Staniarto<sup>(5)</sup>, G. W. Saputro<sup>(6)</sup>, A. D. Kusuma<sup>(7)</sup>

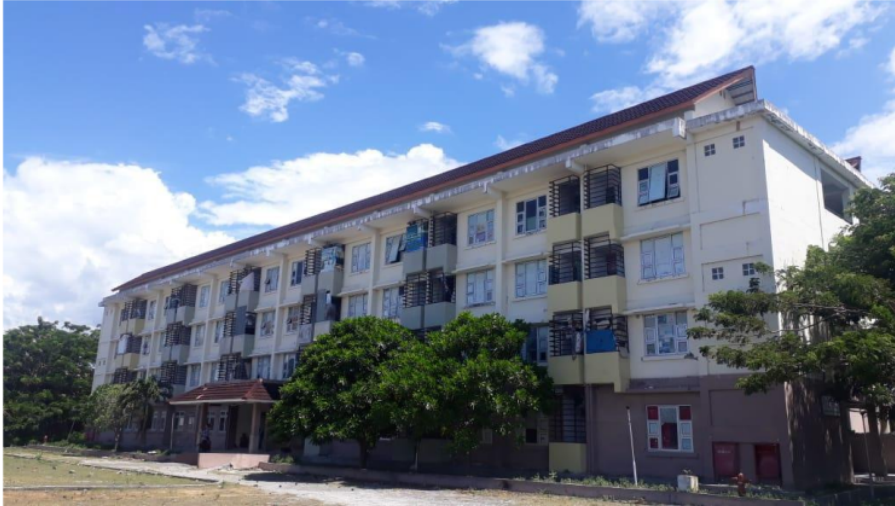
- Moderate damage (2 housing flats): MTs DDI Lonja and UPT Dinas PU Palu (Fig. 2)
- Major damage (1 housing flat): Univ. Tadulako – Palu (Fig. 3).

- Moderate damage (3 housing flats): Univ. Al-Khairat Palu, Rusunawa Pekerja Kota Palu dan UPT Dinas PU Palu
- Major damage (1 building): Univ. Tadulako – Palu

Fig. 2 – Front view of damage occurred on rental low-cost housing flat UPT Dinas PU Palu

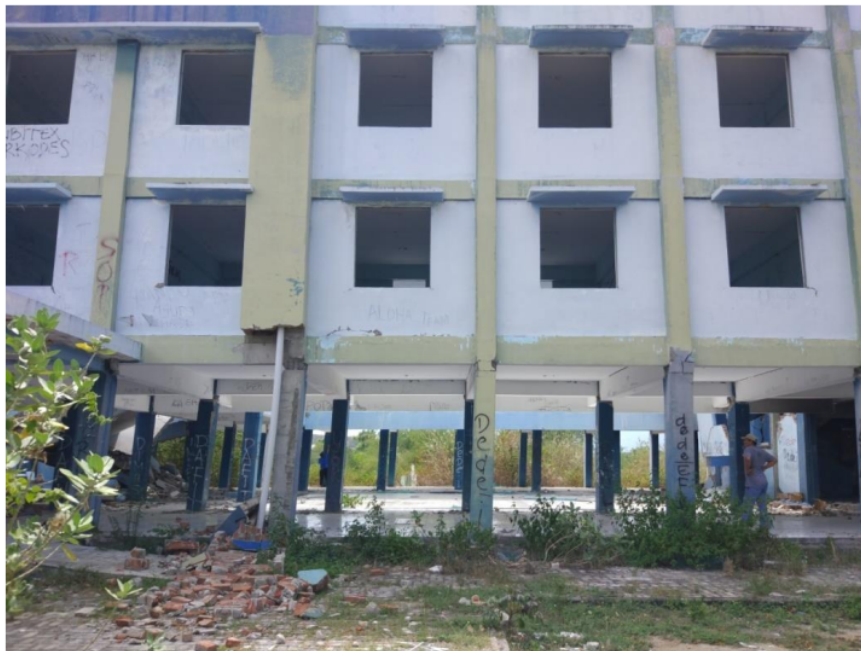
Fig. 3 – Front view of damage occurred on rental low-cost housing flat Univ. Tadulako

Figure 4 shows the distribution of 21 housing flats suffering various degrees of structural damage. These are housing flats built in the period of 2007-2017. As can be seen, most housing flats have only minor damage. This shows that the seismic performance of those housing flats are good as many buildings around them are severely damaged. In other words, the housing flats perform well against designed earthquake load. One housing flat that suffer major damage is housing flat Univ. Tadulako – Palu constructed using conventional reinforced concrete.

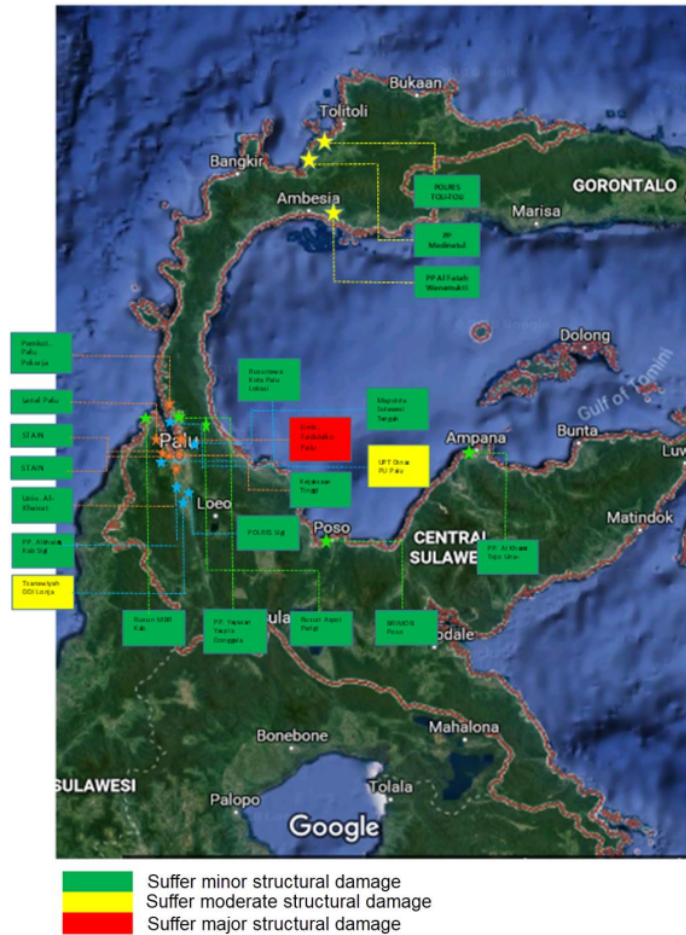
Fig. 4 – Mapping of housing flats suffering structural damage due to earthquake

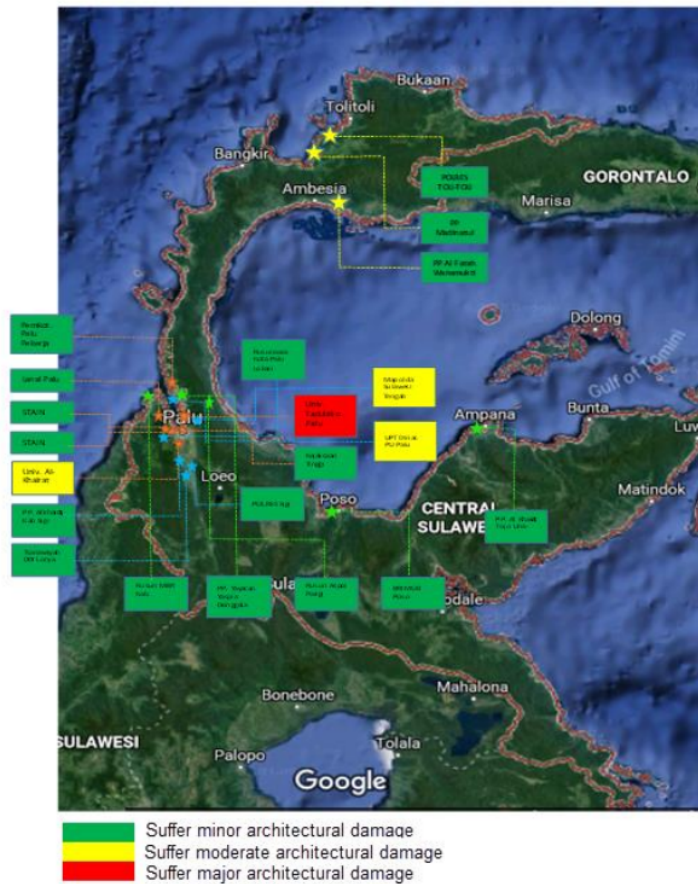
Distribution of 21 housing flats suffering various degrees of architectural damage is shown in Fig. 5. As can be seen, most housing flats have only minor architectural damage.

Fig. 5 – Mapping of housing flats suffering architectural damage due to earthquake
