# USE OF VERTICAL UNBONDED POST TENSIONED ON PRECAST CONCRETE WALL TO COUNTERACT VERTICAL EARTHQUAKE

## USE OF VERTICAL UNBONDED POST TENSIONED ON PRECAST CONCRETE WALL TO COUNTERACT VERTICAL EARTHQUAKE

### 2.1 Visual Investigation of Building

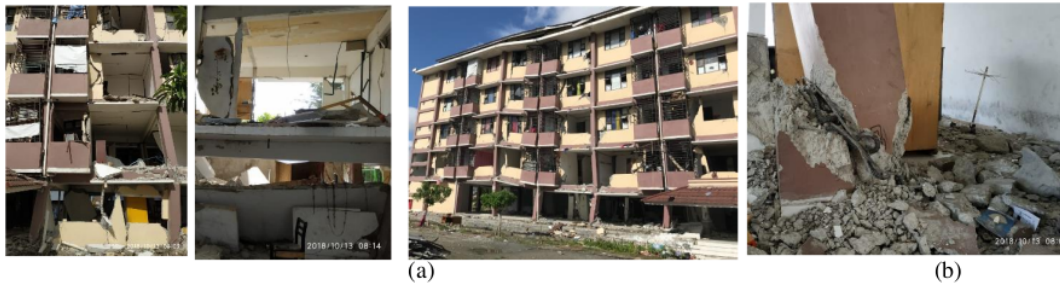
Post-earthquake assessment of building condition<sup>[2][3][4]</sup> of rental low-cost housing flat Lere in Palu was conducted on October 13<sup>th</sup>, 2018. Visual observation and analysis show that this housing flat suffered major damage in both structural and architectural components as can be seen in Figs 1.a and 1.b, respectively.

Fig. 1 – Pictures of damaged rental low-cost housing flat Lere: (a) major architectural damage, (b) major structural damage concentrated on base columns undergone compression failure and combined shear and tensile failure

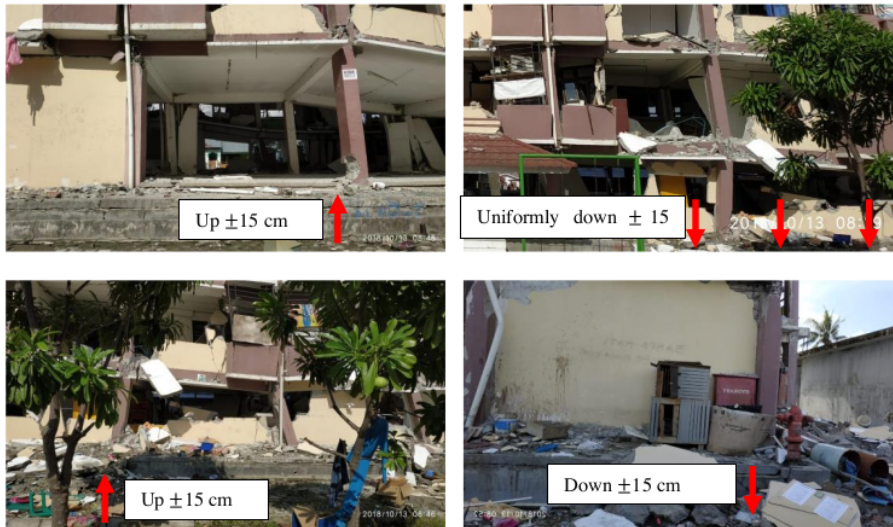
Failure mechanism of structure occurred at rental low-cost housing flat Lere was triggered by vertical earthquake load as dominant load in this earthquake. The wave of vertical load led to significant soil deformation and thus caused one point of structure deforming going down and the other point going up (forming wave-like vertical deformation along length of the building). This failure mechanism can be described using Fig. 2.

Fig. 2 – Soil deformation pattern due to vertical earthquake (pictures continuous along the length of building)

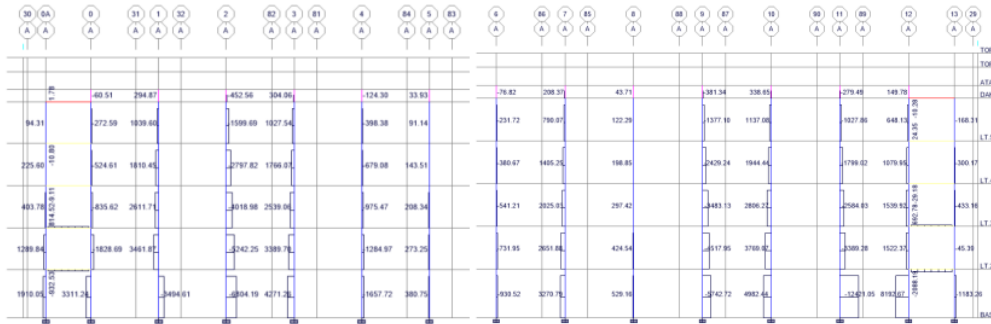
Fig. 4 – Output axial force due to ground displacement

From Fig. 4, it can be seen that vertical movement of ground surface can result in large axial forces in columns. These axial forces have different direction between two adjacent columns. For example, at column 2-A in which ground surface move upwards 15 cm, there is compression force of 6304.2 kN and at adjacent column (column 3-A) in which ground surface displace downwards 15 cm, the column has tensile force of 4271.3 kN. On another example, at column 12-A where the ground surface beneath it move downwards 20 cm, the column has axial compression force of 8192.7 kN and at column 11-A where the ground surface beneath it move upwards 20 cm, the column has axial tensile force of 12421.1 kN. Meanwhile, based on theoretical formula, the compressive and tensile capacity of reinforced concrete column can be evaluated as follows: compressive capacity =  $0.85 f_c' A_g = 0.85 \times 29.05 (350 \times 500) = 4,321,187 \text{ N} = 4321.2 \text{ kN}$  and tensile capacity =  $0.5 \sqrt{f_c'} A_g = 0.50 \times \sqrt{29.05} (350 \times 500) = 471,607.954 \text{ N} = 471.607 \text{ kN}$ .

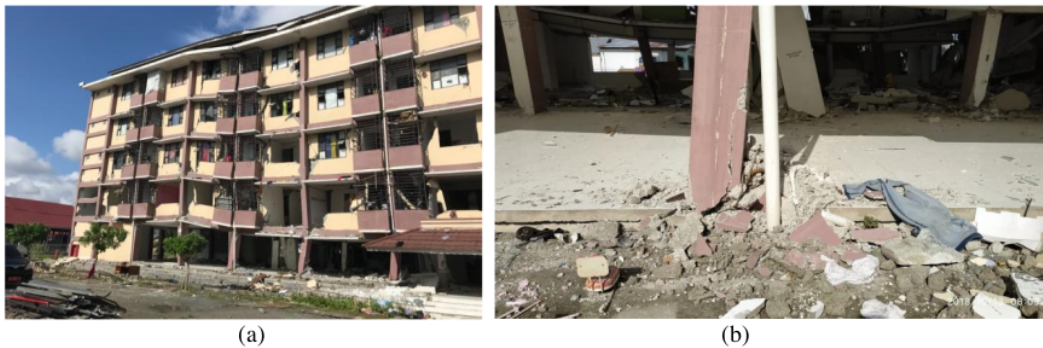
From the above discussion, it is clear that the axial forces, both in tension or in compression, exceed their capacities. As can be seen in Fig. 5.a, column 2-A underwent compression failure. On the other hand, Fig. 5.b shows that column 3-A suffered a combination of tensile and shear failure. Since the tensile capacity of column is much lower than the actual axial tensile force in column, the column was separated into two parts and then displaced to the side due to lateral force as shown in Fig. 5.b. Thus, from data and computer model simulation, considering that the large vertical earthquake load coming earlier than the of horizontal earthquake load, it explains the damage mechanism took place on building under investigation.

Fig. 5 – Structural damage: (a) compression failure in column, (b) tensile-shear failure in column

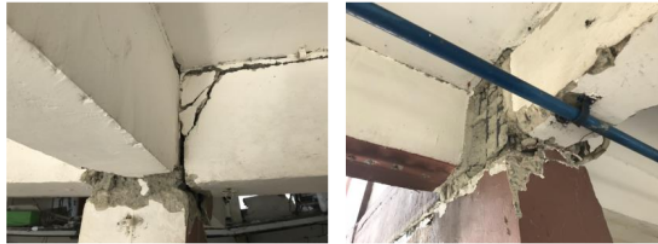
Fig. 8 – Damage of beam-column joint due to earthquake

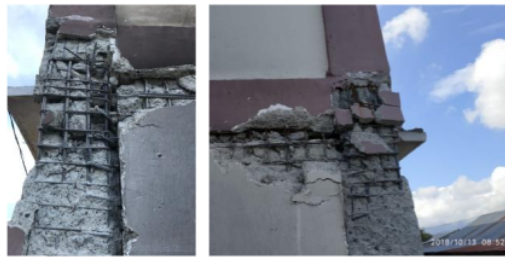
Fig. 9 – Stirrups installed properly in column, beam and joint, concrete crushing because of tension
