Structural Assessment of Rental Housing Flat Lere in Palu Affected by Palu Earthquake on September 28, 2018

Abstract. Rental Housing flat Lere in Palu, Central Sulawesi is one of rental housing flats built by Directorate General Cipta Karya, Department Public Works and Housing in cooperation with local government of Palu during fiscal year of 2010-2011. It is one of buildings damaged by Palu earthquake. To assess the severity of building damage induced by earthquake, building structural engineering experts were conducting engineering investigation. Data from field investigation were used to develop computer model employed in simulating damage mechanism. By running structural model, one can explain damage mechanism in building during the earthquake. From this study, the building is considered severely damage and need to be destroyed. To rebuilt in the area, it is necessary to use structural system that highly resistance against vertical earthquake and to use updated building design codes.

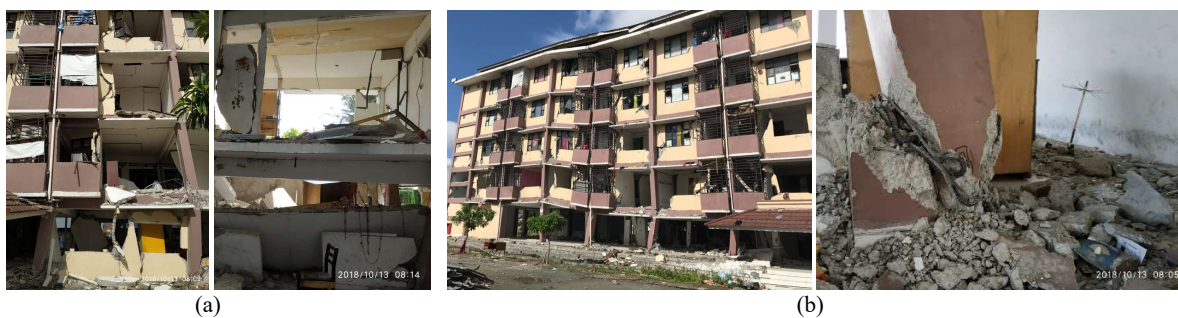
Survey of building condition assessment post-earthquake taken place on September 28, 2018 at rental low-cost housing flat Lere in Palu conducted on October 13, 2018. Based on visual observation and analysis show that this housing flat suffered major damage in both structure and architectural components as can be seen in Figure 1.a and 1.b, respectively.

FIGURE 1. Pictures of damaged rental low-cost housing flat Lere: (a) major architectural damage, (b) major structural damage concentrated on base columns undergone compression failure and combined shear and tensile failure

Based on the detailed evaluation conducted in this study, the building is determined to be unrepairable and thus needs to be destroyed. If the building is to be rebuilt, it is better to be relocated, built using high performance earthquake resistance structural system that is able to resist vertical earthquake and use recent design building codes.

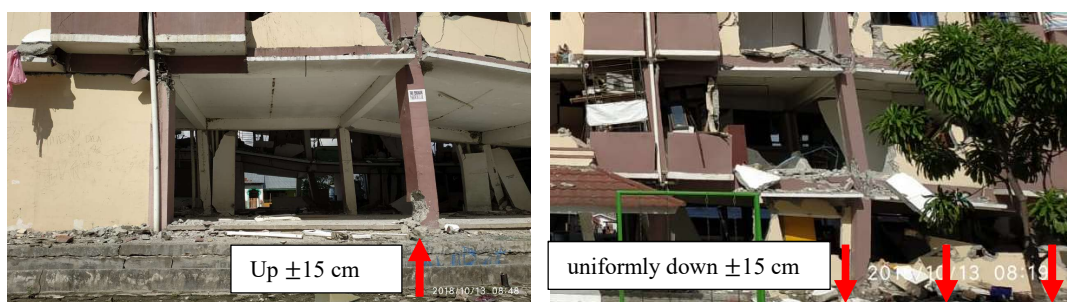
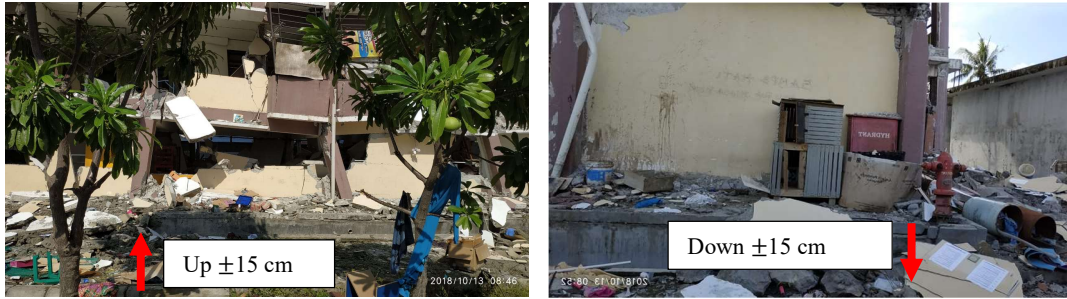
Failure mechanism of structure occurred at rental low-cost housing flat Lere was triggered by vertical earthquake load that was dominant load in this earthquake. The wave of vertical load led to significant soil deformation and thus caused one point of structure deforming down and the other point up (forming wave-like vertical deformation along length of building). This failure mechanism can be described using Figure 2.

FIGURE 2. Soil deformation pattern due to vertical earthquake (pictures continuous along the length of building)

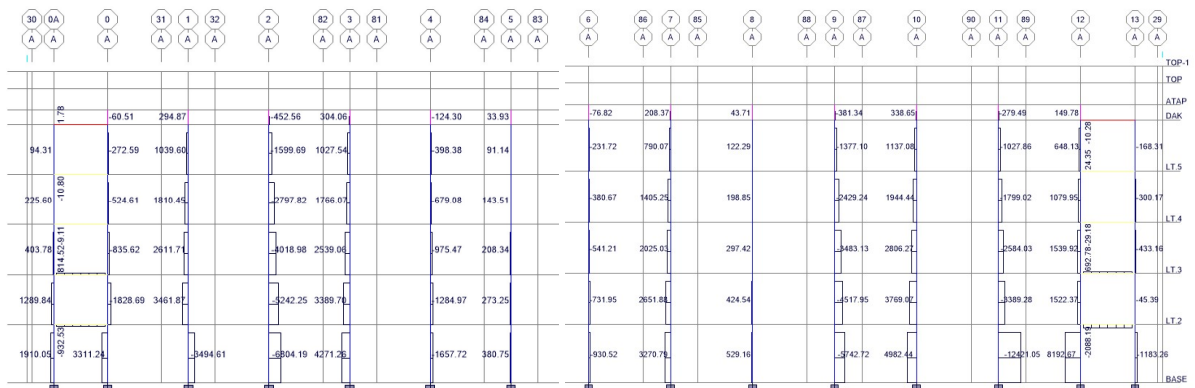
FIGURE 4. Output axial force due to ground displacement

From Fig. 4, it can be seen that vertical movement of ground surface can result in large axial forces in columns. These axial forces have different direction between two adjacent columns. For example, at column 2-A in which ground surface move up 15 cm, there is compression force of 6304.2 kN and at adjacent column (column 3-A) in which ground surface displace down 15 cm, the column has tensile force of 4271.3 kN. On another example, at column 12-A where the ground surface beneath it move down 20 cm, the column has axial compression force of 8192.7 kN and at column 11-A where the ground surface beneath it move up 20 cm, the column has axial tensile force of 12421.1 kN. Meanwhile, based on theoretical formula, the compressive and tensile capacity of reinforced concrete column can be evaluated as follows: compressive capacity = $0,85 f'c' Ag = 0,85 \times 29,05 (350 \times 500) = 4.321.187 \text{ N} = 4321.2 \text{ kN}$ and tensile capacity = $0,5 \sqrt{f'c'} Ag = 0,60 \times \sqrt{29,05} (350 \times 500) = 3.050.250 \text{ N} = 404.23 \text{ kN}$.

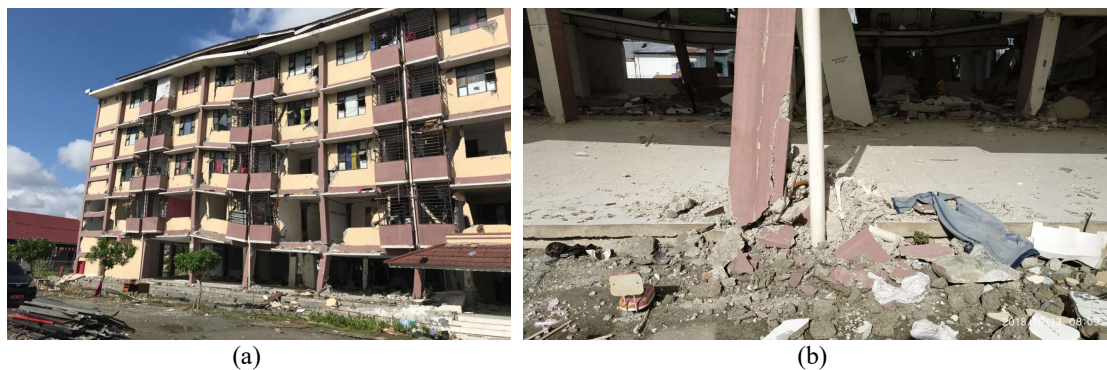
From above discussion, it is clear that both in tension or in compression the axial forces occurred in columns exceed their capacities. As can be seen in Fig. 5.a, column 2-A underwent compression failure. On the other hand, Fig. 5.b shows that column 3-A suffered a combination of tensile and shear failure. Since the tensile capacity of column is much lower than the axial tensile force in column, the column was separated into two parts and then displaced to the side due lateral force as shown in Fig. 5.b. Thus, from data and computer model simulation and considering that the large vertical earthquake load coming earlier than that of horizontal earthquake load, it can explain the damage mechanism taken place on building under investigation.

FIGURE 5. Structural damage: (a) compression failure in column, (b) tensile-shear failure in column

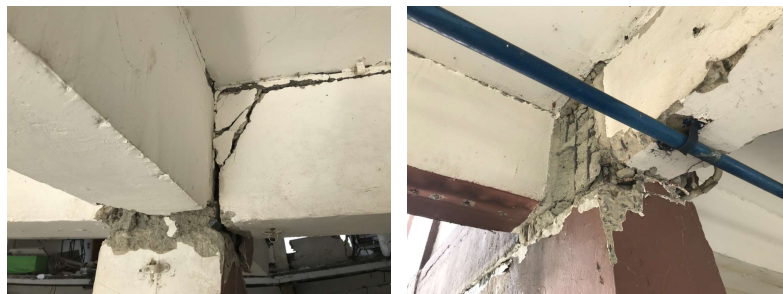
FIGURE 8. Damage of beam-column joint due to earthquake

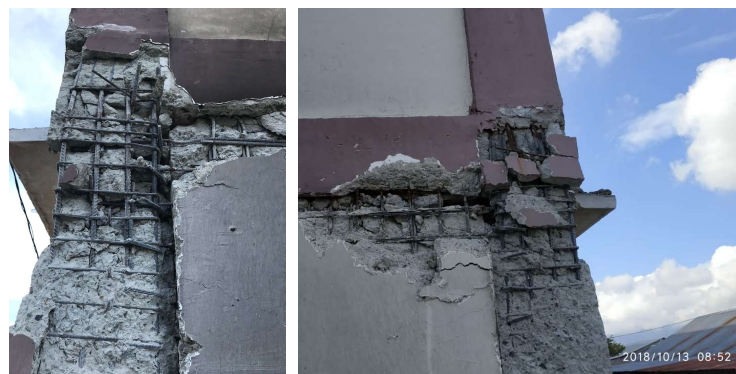
According to Indonesian seismic design code (SNI 03-1726-2002) and concrete building code (SNI 03-2843-2002), moderate moment resisting frame structure can still be used for region medium earthquake risk (zone 3,4,5), without using shear wall. Shear wall in this building is only provided in the first floor to prevent soft story effect. Damage mode of sway mechanism that was employed based on the assumption the earthquake would not occur in this building with the dominant vertical earthquake load. Random column failure in the first-floor results in random failure mode on structure above the first floor. There is no clear damage pattern on every component of the structure. However, if one compares damage evolution from several components with those crack pattern from testing shown in Fig. 7, one can see similarity in pattern. Cracks started from beam and then go into the joint as can be seen in Fig. 8. Stirrups in column and joint were properly installed, but dominant vertical earthquake load led to concrete crushing as shown in Fig. 9.

FIGURE 9. Stirrups installed properly in column, beam and joint, concrete crushing because of tension
