# USE OF VERTICAL UNBONDED POST TENSIONED ON PRECAST CONCRETE WALL TO COUNTERACT VERTICAL EARTHQUAKE

## USE OF VERTICAL UNBONDED POST TENSIONED ON PRECAST CONCRETE WALL TO COUNTERACT VERTICAL EARTHQUAKE

### 2.1 Visual Investigation of Building

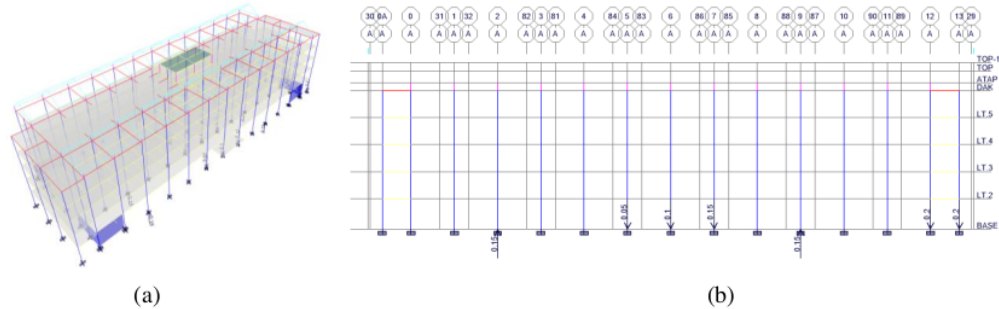
Fig. 3 – ETABS Structural model for rental low-cost housing flat Lere with input ground displacement according to measurements from the field: (a) 3D model building, (b) model section along the length of building

To take into account the effect of vertical earthquake causing damage in building in the form of vertical deformation, structural model including the vertical deformation at the base (ground displacement) based on deformation observed on the field as shown Fig. 3, is developed. The structural model was prepared using structural analysis software ETABS (computer aided design).

From Fig. 4, it can be seen that vertical movement of ground surface can result in large axial forces in columns. These axial forces have different direction between two adjacent columns. For example, at column 2-A in which ground surface move upwards 15 cm, there is compression force of 6304.2 kN and at adjacent column (column 3-A) in which ground surface displace downwards 15 cm, the column has tensile force of 4271.3 kN. On another example, at column 12-A where the ground surface beneath it move downwards 20 cm, the column has axial compression force of 8192.7 kN and at column 11-A where the ground surface beneath it move upwards 20 cm, the column has axial tensile force of 12421.1 kN. Meanwhile, based on theoretical formula, the compressive and tensile capacity of reinforced concrete column can be evaluated as follows: compressive capacity =  $0.85 f_c' A_g = 0.85 \times 29.05 (350 \times 500) = 4,321,187 \text{ N} = 4321.2 \text{ kN}$  and tensile capacity =  $0.5 \sqrt{f_c'} A_g = 0.50 \times \sqrt{29.05} (350 \times 500) = 471,607.954 \text{ N} = 471.607 \text{ kN}$ .

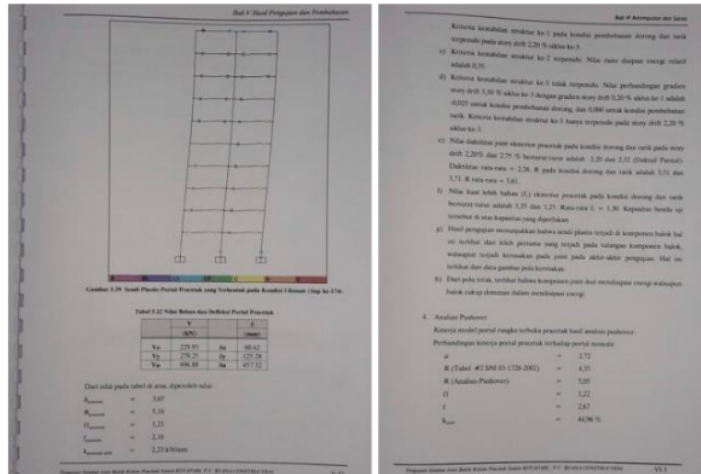
Fig 5 – Lateral resistance system category of precast system which is used

Structural components of 4<sup>th</sup> central low-cost housing flat Lere in Palu use precast system that has been tested at structural laboratory of the Research Institute of Human Settlement and Institute of Road Engineering Ministry of Public Works and Housing. Reduction factor  $R$  of 4.35 – 5.05 means that this system fall into structural category moderate moment resisting frame as shown in Fig. 6.

According to Indonesian seismic design code (SNI 03-1726-2002) and concrete building code (SNI 03-2843-2002), moderate moment resisting frame structure can still be used for region medium earthquake risk (zone 3, 4, 5), without using shear wall. Shear wall in this building is only provided in the first floor to prevent soft story effect. Damage mode of sway mechanism that was employed based on the assumption of the earthquake would not occur in this building with the dominant vertical earthquake load. Random column failure in the first-floor results in random failure mode on structure above the first floor. There is no clear damage pattern on every component of the structure. However, if one compares damage evolution from several components with those crack pattern from testing shown in Fig. 7, one can see similarity in pattern. Cracks started from beam and then go into the joint as can be seen in Fig. 8. Stirrups in column and joint were properly installed, but dominant vertical earthquake load led to concrete crushing as shown in Fig. 9.
