Structural Assessment of Rental Housing Flat Lere in Palu Affected by Palu Earthquake on September 28, 2018

Abstract. Rental Housing flat Lere in Palu, Central Sulawesi is one of rental housing flats built by Directorate General Cipta Karya, Department Public Works and Housing in cooperation with local government of Palu during fiscal year of 2010-2011. It is one of buildings damaged by Palu earthquake. To assess the severity of building damage induced by earthquake, building structural engineering experts were conducting engineering investigation. Data from field investigation were used to develop computer model employed in simulating damage mechanism. By running structural model, one can explain damage mechanism in building during the earthquake. From this study, the building is considered severely damage and need to be destroyed. To rebuilt in the area, it is necessary to use structural system that highly resistance against vertical earthquake and to use updated building design codes.

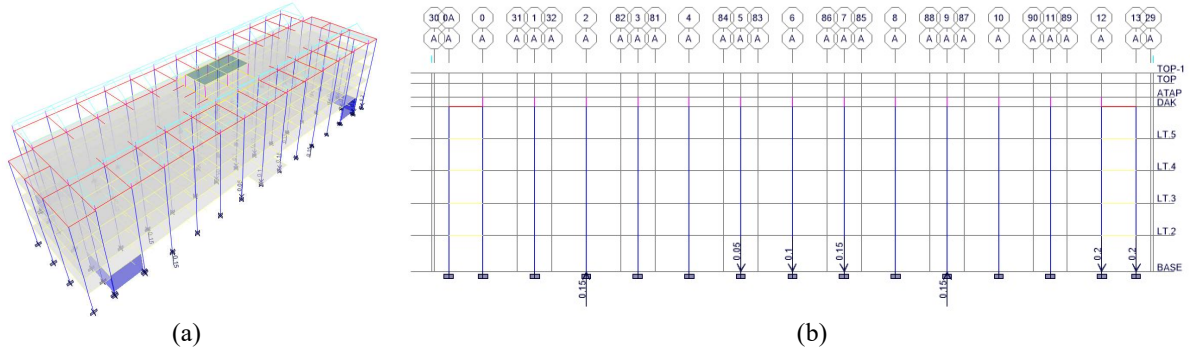
To take into account the effect of vertical earthquake causing damage in building in the form of vertical deformation, the developed structural model includes the vertical deformation at the base (ground displacement) based on deformation observed on the field as shown Fig. 3. The structural model was prepared using structural analysis software ETABS as a tool (computer aided design).

FIGURE 3. ETABS Structural model for rental low-cost housing flat Lere with input ground displacement according to measurements from the field: (a) 3D model building, (b) model section along the length of building

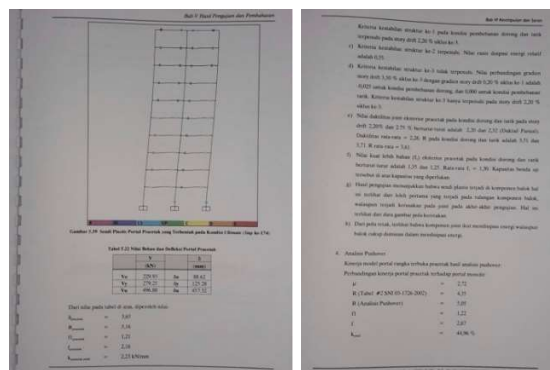
Structural component of rental low-cost housing flat Lere in Palu uses precast system that has been tested at structural laboratory of the Research Institute of Human Settlement and Institute of Road Engineering Ministry of Public Works and Housing. Reduction factor R of 4.35 – 5.05 means that this system fall into structural category moderate moment resisting frame as shown in Fig. 6.

FIGURE 6. Lateral resistance system category of precast system yang digunakan

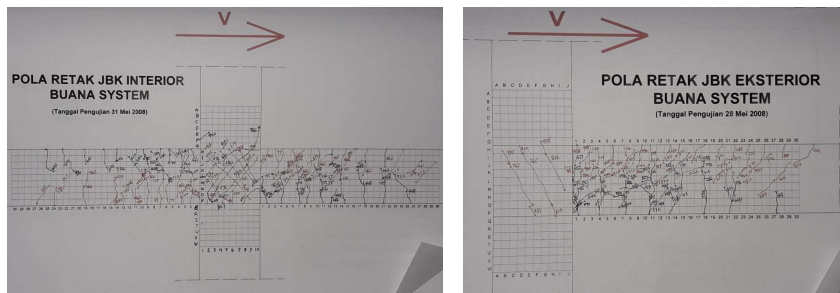
FIGURE 7. Crack pattern at interior and exterior beam-column joints during testing in Laboratory
